Capital Needs Assessment

Wilkins Elementary School

June 1, 2017

Preliminary Report

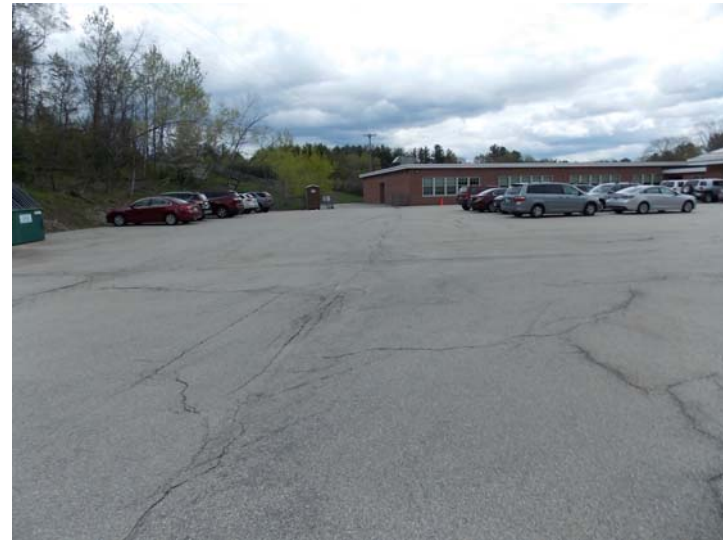
A view of cracks in the asphalt paving.

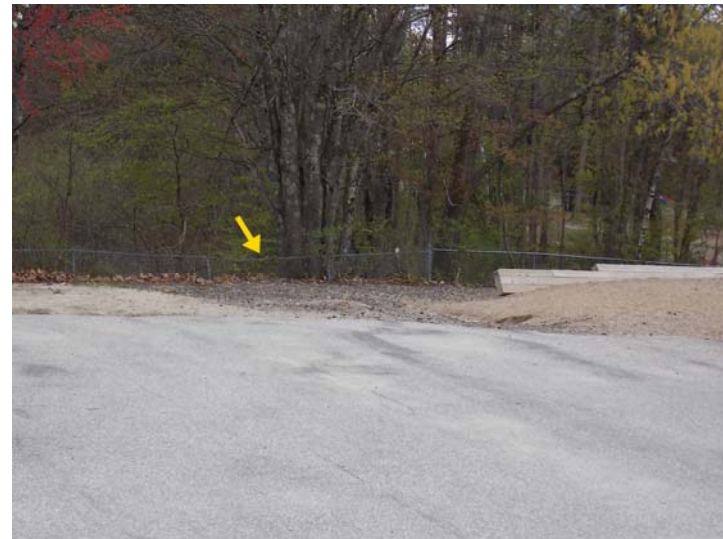
2. There is significant erosion at the play area that has destabilized a retaining wall and has covered the majority of a surrounding chain link fence. The plan includes an allowance in Year 1 to address the erosion, including re-grading the land, and possibly using open grid pavers to improve and control drainage in this area. This cost also includes repairing the retaining wall. The chain link fence repair is shown concurrent to this landscaping effort.
3. The parking lots, driveways, and walkways have areas that are isolated cracks. The cost to repair these surfaces (crack-fill, sealcoat, and re-stripe) is shown in Years 2, 7, and 12; resurfacing is shown in Year 17.
4. The play equipment is to be replaced in Year 10. The plan also includes the cost for future servicing to the septic system and leaching field, in Year 10.

The height of the perimeter fence has been reduced by almost 50% due to the erosion at the playground.

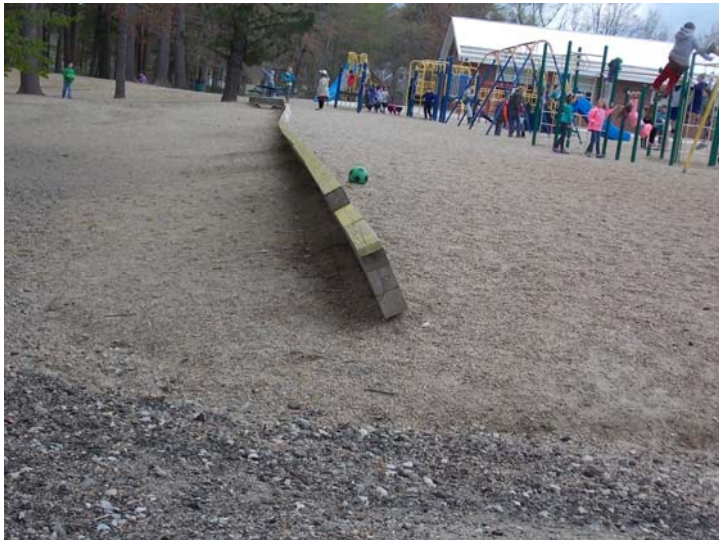
This retaining wall is no longer upright and needs to be addressed in the near term.

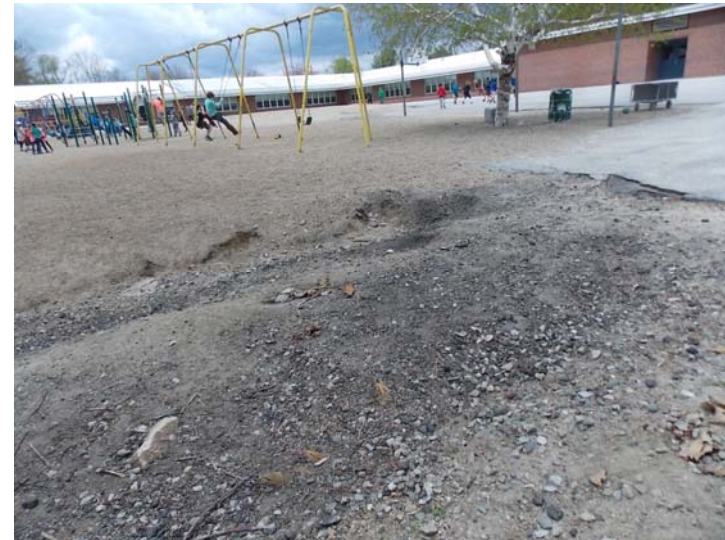
An eroded area at the edge of the playground.

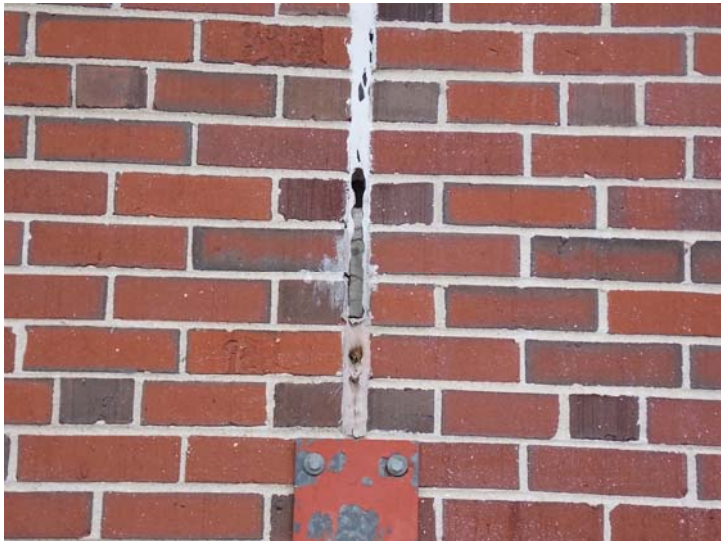
A building control joint that has dried and open caulking.

13. The cost to replace the caulking, in which there were sections found to be dried, cracked, and in some isolated areas voids were also noted, is shown in Years 1 and 16. The wood trim (fascia boards and soffits) are to be repaired and repainted in Years 1, 8, and 15. The shed that is attached to the main building clad with plywood, which is starting to deteriorate. The plan includes the cost to replace the plywood with a cementitious fiberboard product in Year 1. The brickwork appears to be in good condition and future repointing is shown in Year 16. The vinyl siding is to be power washed every six years starting in Year 4.

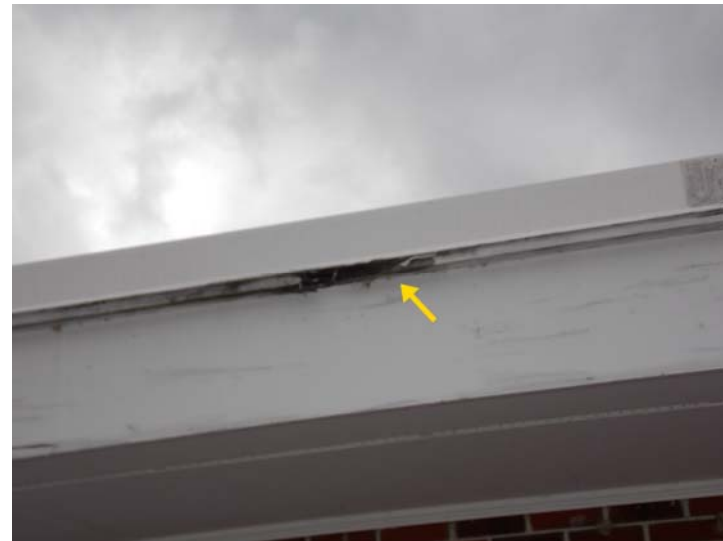
A close-up of damage at the top of a fascia board (wood trim near the roof line of the main building).

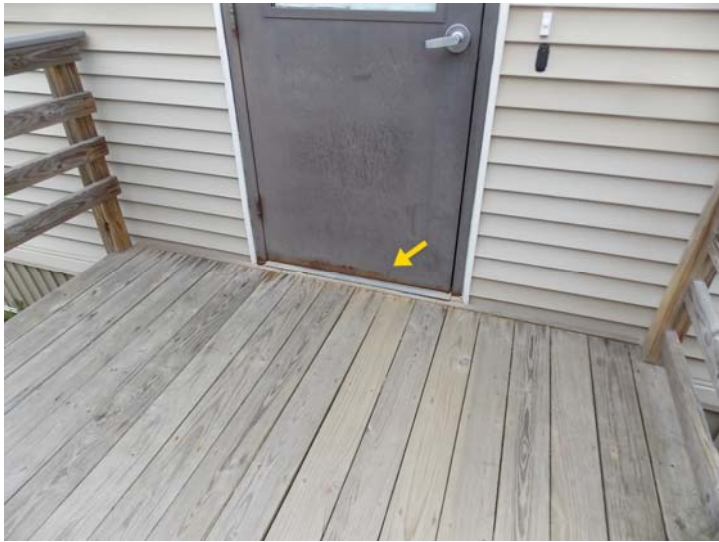
An exterior door on one of the portable buildings; note the rust at the bottom of the door.

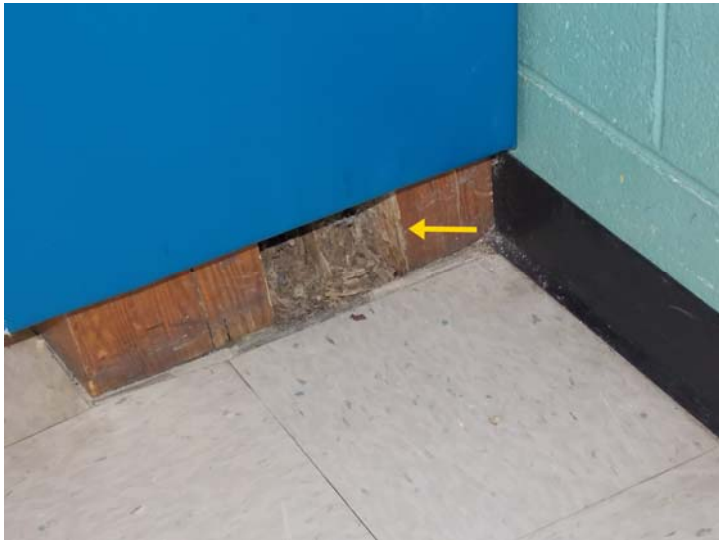
A close-up of previous termite damage. Maintenance continues to monitor the building any signs of reoccurrence.

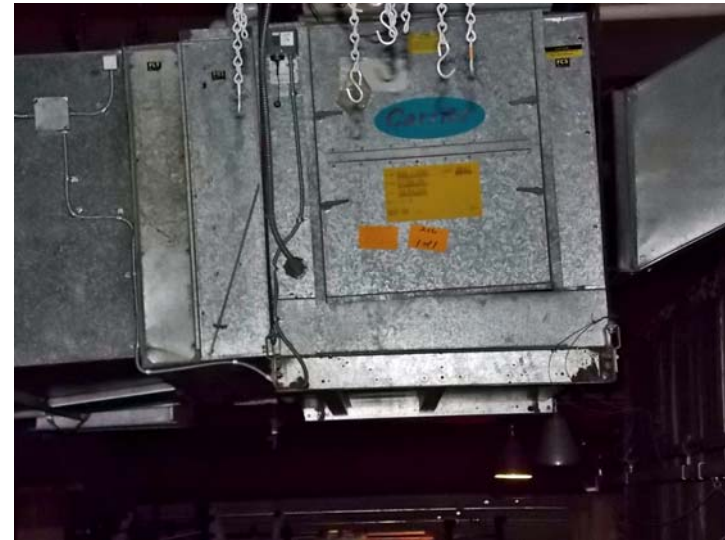
This air handler serves the Multipurpose Room.

10. The ceiling mounted air handler that serves the Multipurpose Room is to be upgraded (heating coil, controls, blower motor, etc.) in Year 5. The split direct expansion (DX) air conditioners are to be replaced in Year 10. The plan also anticipates replacing damaged finned tube radiation starting in Year 10. The exhaust fans are to be upgraded in Year 12.

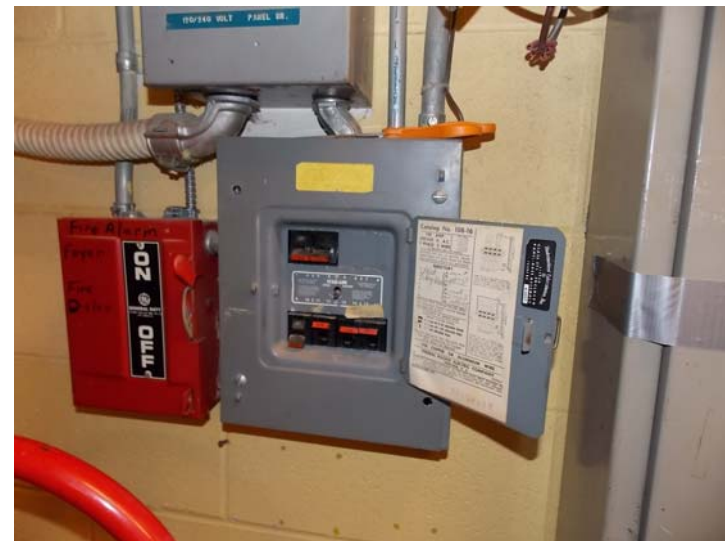
11. An original Federal Pacific circuit breaker panel (Stab-Lok model) is to be replaced in the first year of the plan. This type of

circuit breaker panel is a safety concern in that it has a history not reliably reacting to an electric overload condition. An allowance to upgrade the video monitoring system, public address system, and the central clock is Years 2, 9, and 16. The battery powered emergency lights are to be replaced in Years 7 and 17. The fire alarm system is to be upgraded in the second half of the plan in Year 12.

This FPE circuit breaker panel should be replaced in the near-term. These panels do not reliably react to electric overload conditions.
