Capital Needs Assessment

Clark School

May 31, 2017

Preliminary Report

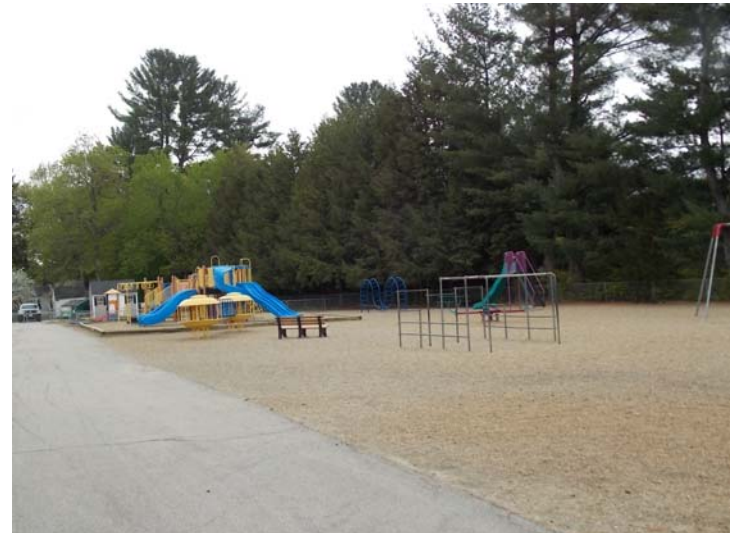
The play area is located behind the building and sits on a pea-stone base.

3. The play equipment is to be replaced in Year 10. Interlocking rubber mats should be considered as the base for the play equipment to replace the existing pea-stone base. Also shown in Year 10 is the cost for future servicing to the septic system and leaching field. The landscaping is to be upgraded in Year 12 and the chain link fence is to be replaced toward the end of the plan in Year 17.

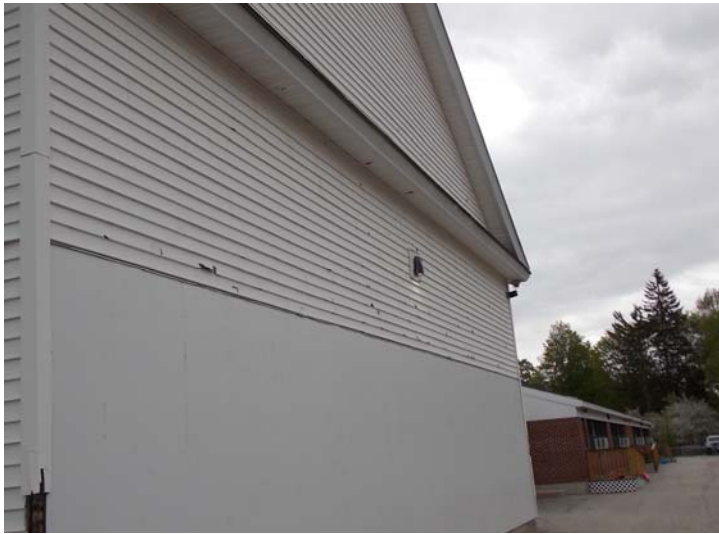
13. The vinyl siding, especially on the new building wing has a number of areas damaged by impact. Also, the T1-11 siding is showing signs of initial deterioration. The plan includes the costs to replace these existing building siding materials with a cementitious fiberboard product in Year 1, which will provided a more resilient and effective exterior wall finish than either the vinyl or T1-11. The brickwork appears to be in good condition and future repointing is shown in Year 16.
14. An allowance for anticipated failed window glazing replacement is shown starting in Year 12. Replacement of the service doors is shown in Year 18 and the secondary doors (classrooms and hallway) in Year 20.

The vinyl siding on the newer building wing has areas of impact damage.

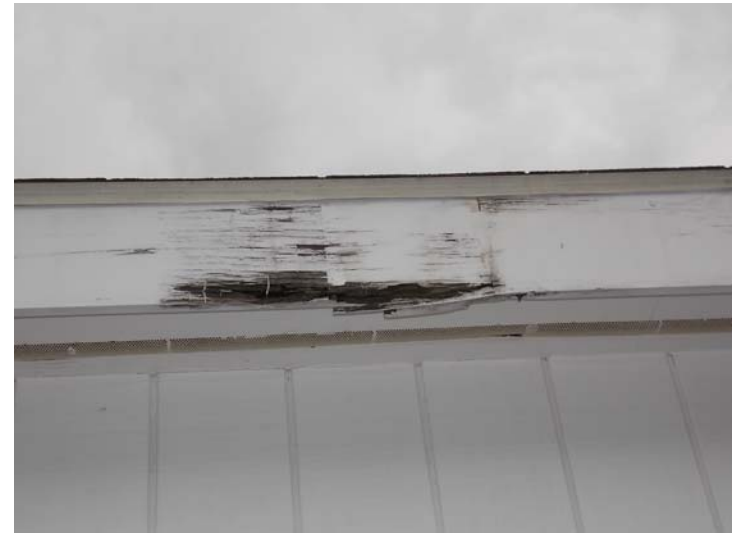
A close-up of deteriorating wood trim above the T-1-11 siding.

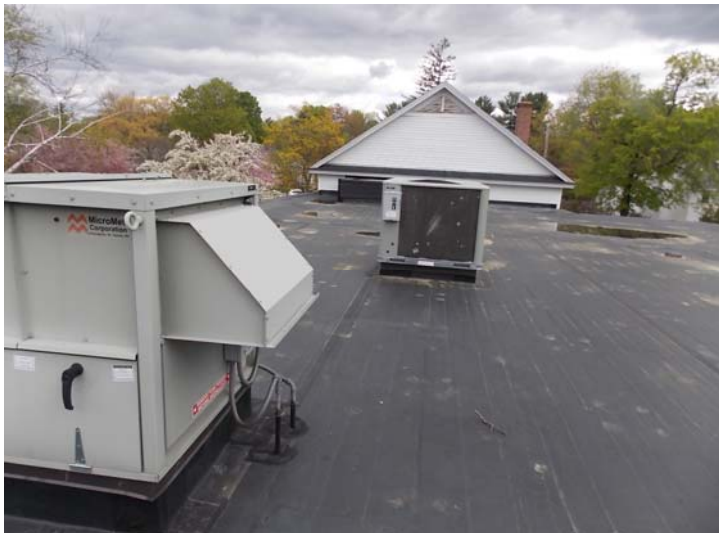
A view of the rubber membrane roofing (over the main portion of the school and several rooftop units). In the background is the original building wing.

16. The plan includes the cost to reseal the seams of the rubber membrane in Year 10, to help extend the roof covering's useful life; the cost to replace the membrane is shown in Year 16. The architectural shingles are also to be replaced in Year 20.

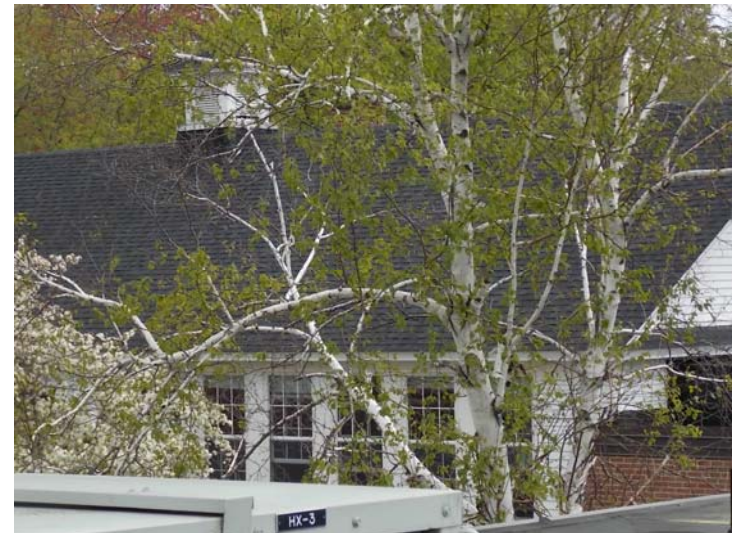
The pitched roof of the original building is covered with architectural shingles (which is also used on the other pitched roofs).

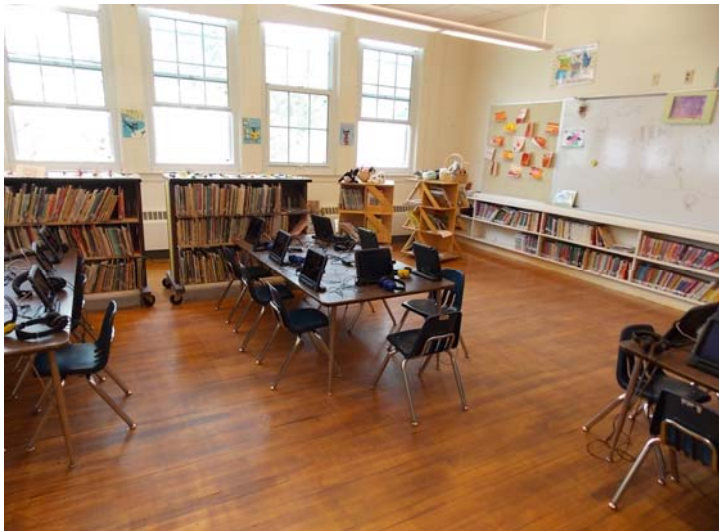
21. The concern about overheating in the library was discussed during the assessment. The overheating could be the result of standby heat that is being transferred from the hydronic heat distribution piping that runs under this space. One possible solution is to add, in Year 1, a thermostat-controlled variable speed exhaust fan. This fan would operate in a slow continuous mode until space temperatures exceed the predetermined temperature setting; at which point the fan speed increases to effectively vent the higher temperatures. This item should be discussed at the client review meeting.

A view of the library located on the upper floor of the original building wing.

20. Future replacement of ceiling panels and repainting in the other program areas is shown in Years 7 and 17. The VCT is to be replaced in Year 17. The library furnishing and equipment replacement is shown in Years 9 and 19.

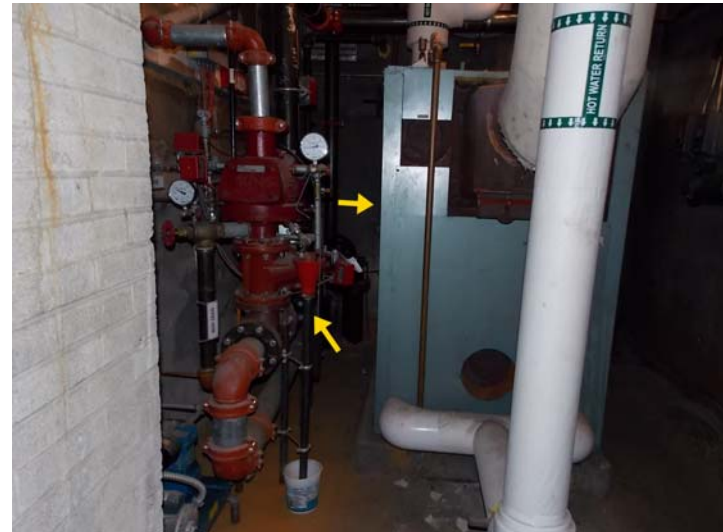
The original oil-fired boiler is on the right and the fire sprinkler connection is on the left.

- 4. Costs related to the development's boilers and boiler room systems total \$121,989 or \$4.52 per square foot in inflated dollars.**
5. The cost to upgrade the EMS is shown in Years 3, 11, and 19. The original boiler is to be replaced in Year 7, after 30 years of use. The plan also includes a service allowance in Year 10 for the newer boiler and replacement cost for the circulating pumps in Year 17. The DHW tank is to be replaced every 12 years starting in Year 4.

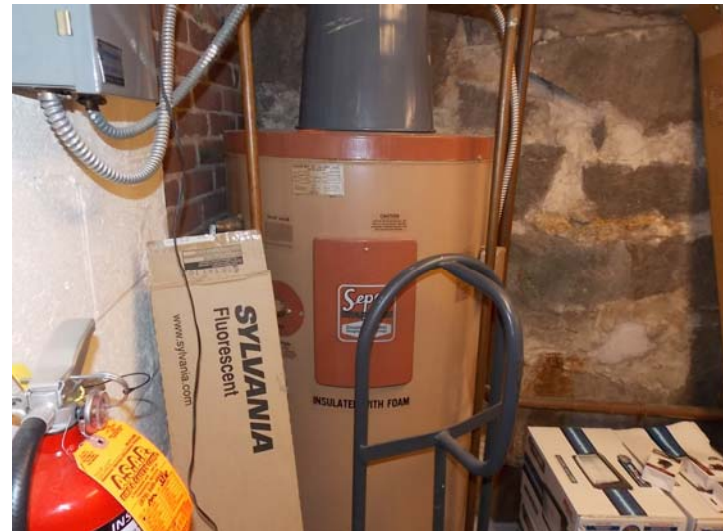
This 80-gallon electric heated DHW tank serves the entire facility.

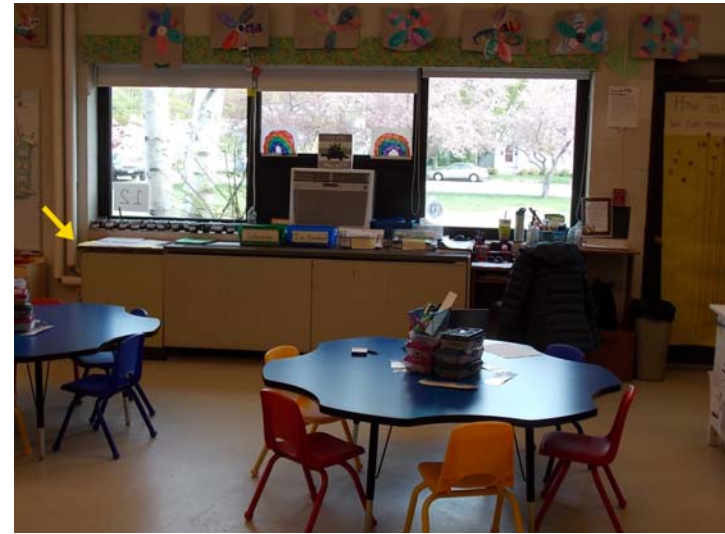
8. A recent air quality study performed by a third party, showed several areas where carbon dioxide (CO₂) readings exceeded the desired level of 1,000 ppm (the maximum level for acceptable ventilation), indicating a need to provide reliable ventilation throughout the facility. The performance of the rooftop units should be monitored to ensure that adequate ventilation is provided throughout the entire facility.

This classroom has a through-wall convector (arrow) to provide heating and fresh air ventilation.
