Capital Needs Assessment

Prepared for:

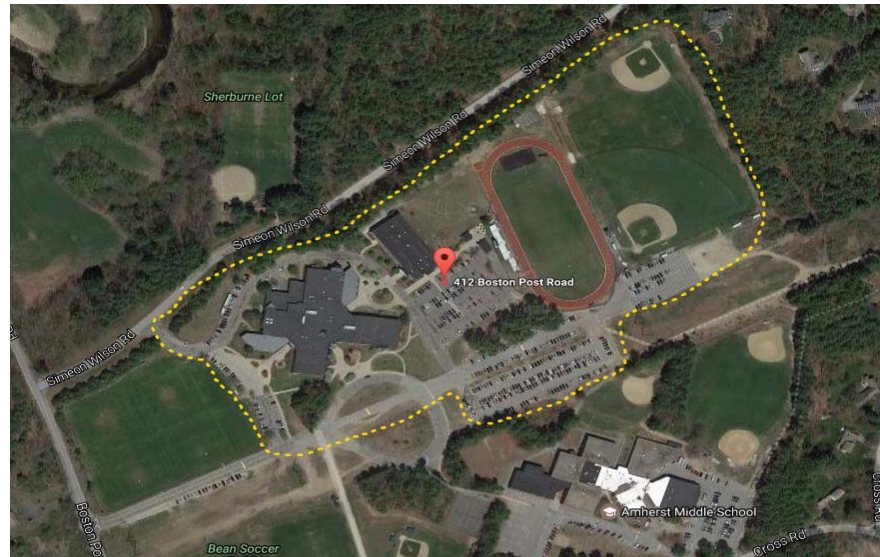
Property Description:

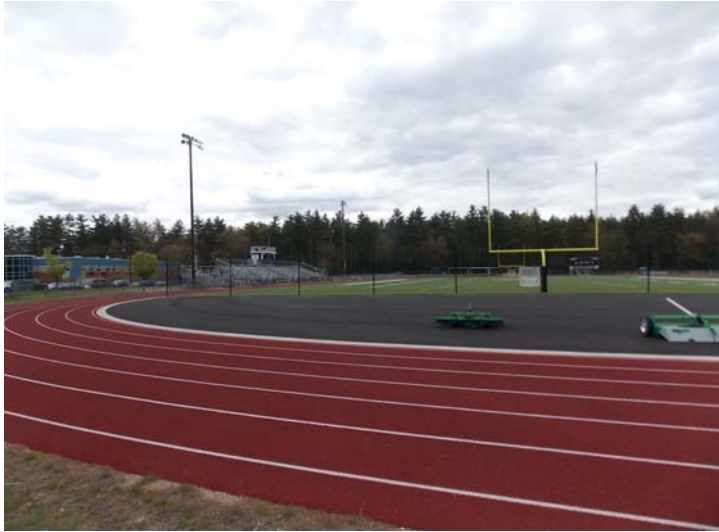
The running track and football field were recently renovated.

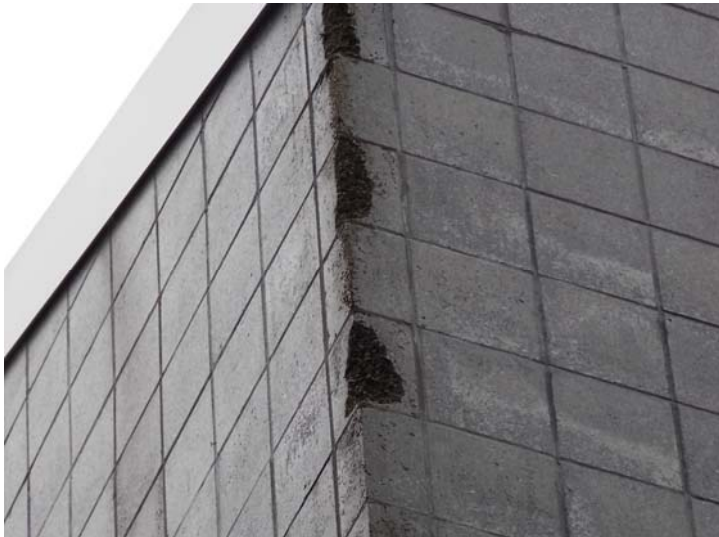
A close-up of deteriorating masonry blocks.

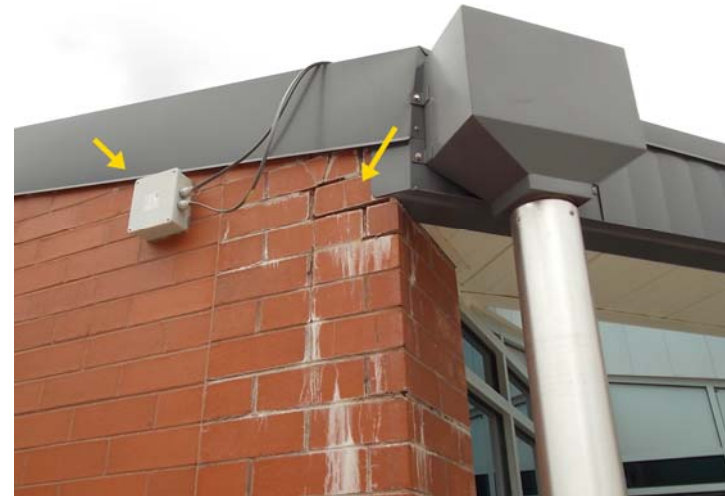
An isolated area of mortar loss, damaged bricks, and efflorescence on the main building (right arrow). Also shown is a snow melt device (left arrow) designed to keep the scupper and downspout from freezing.

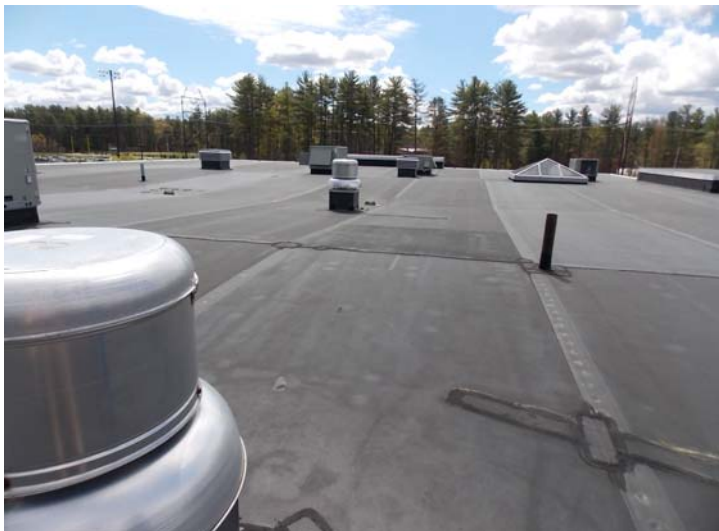
A view of the membrane covering on the annex building's roof.

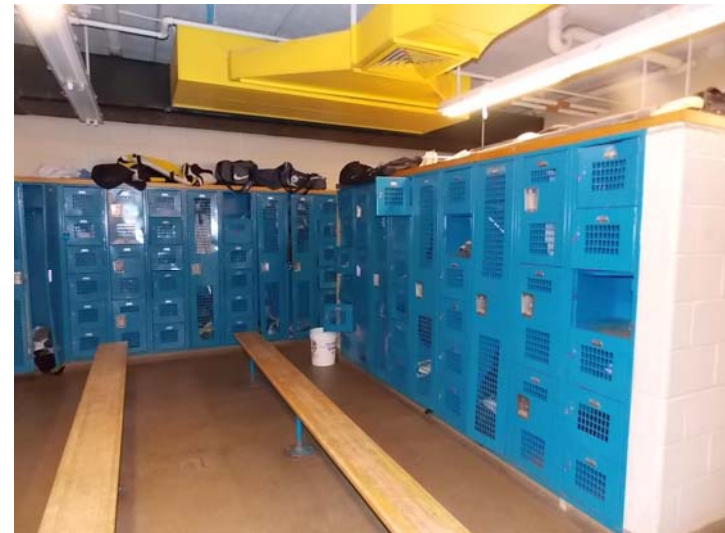
A number of lockers within the Boys' locker room have impact damage.

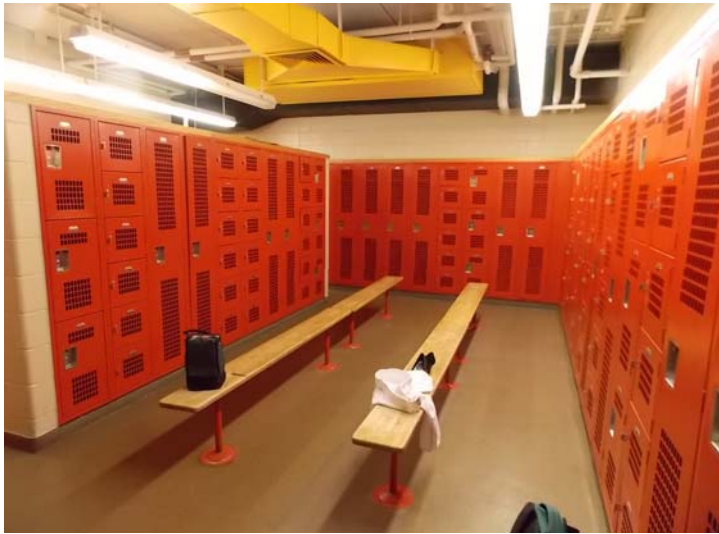
The Girls locker room was found to be in good condition.

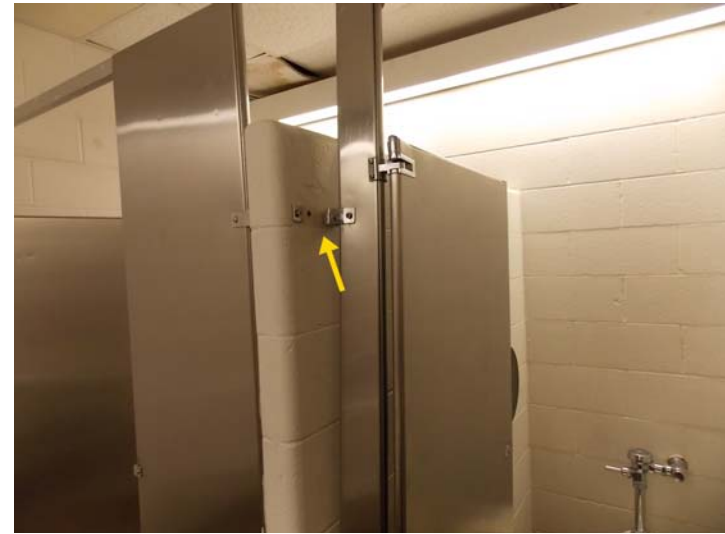
A damaged bathroom partition.

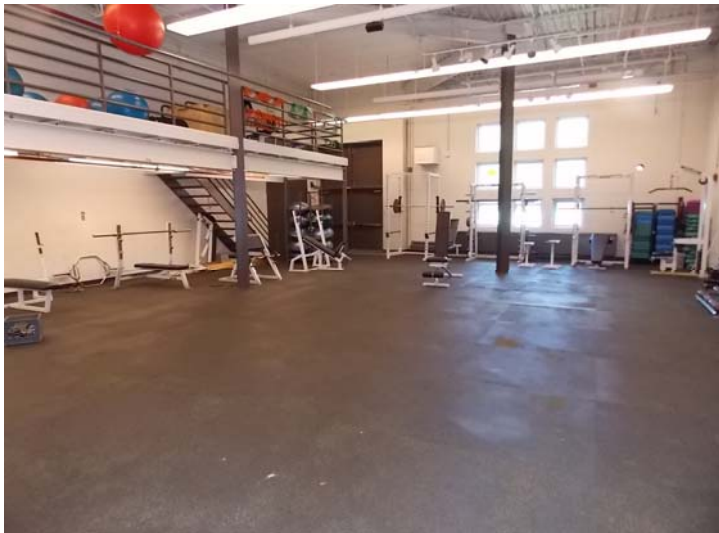
The weight room has a rubber mat floor, and painted surfaces.

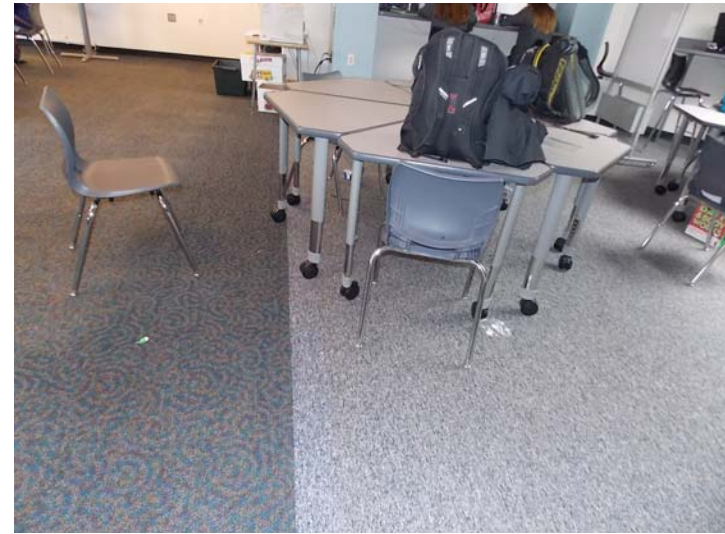
A close-up of different carpeting in a student lounge. Carpet tiles should be considered to help maintain a consistent appearance when replacing damaged sections.

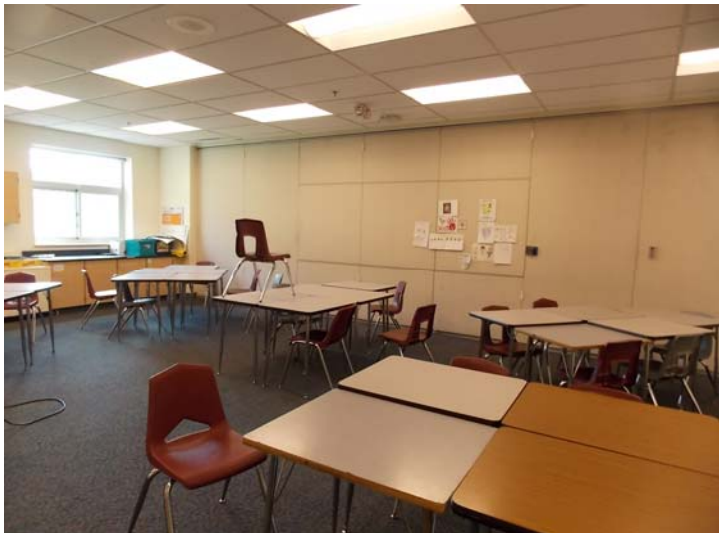
Classrooms have ceiling tiles, painted walls, and carpeted floors.

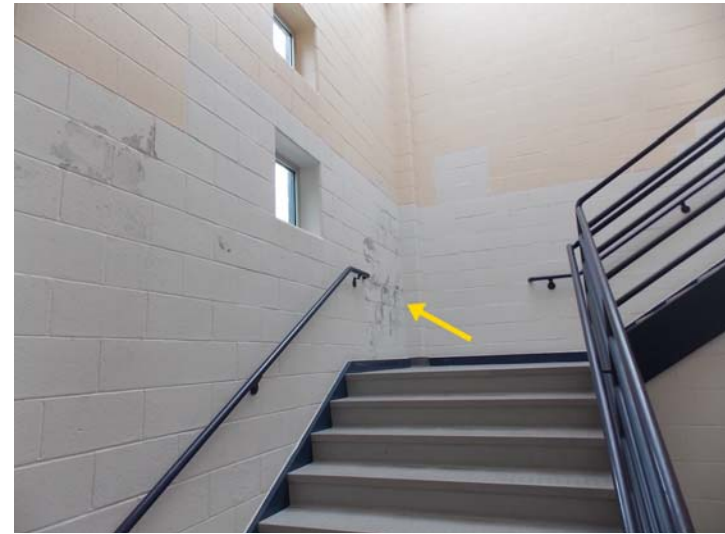
Moisture damage observed in one of the stairwells.

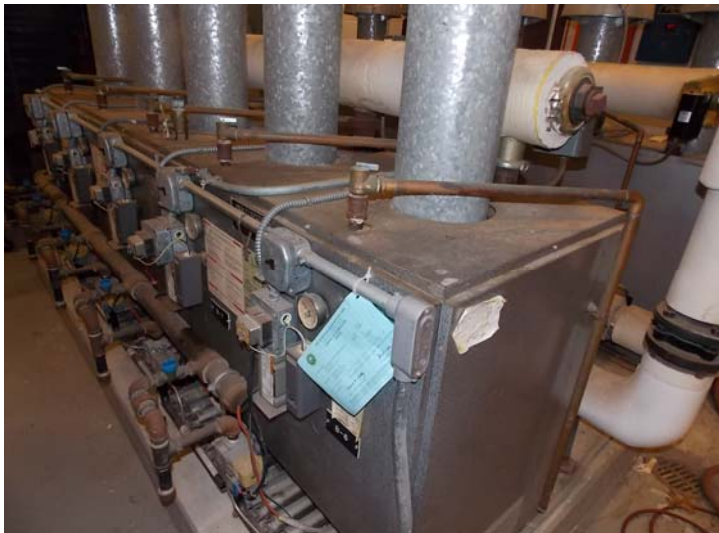
This boiler plant produces hydronic heat for the main building.
