Capital Needs Assessment

Prepared for:

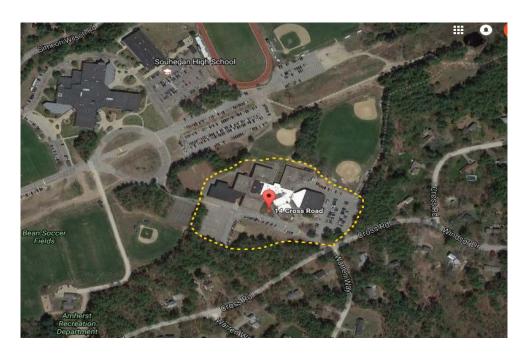
Property Description:

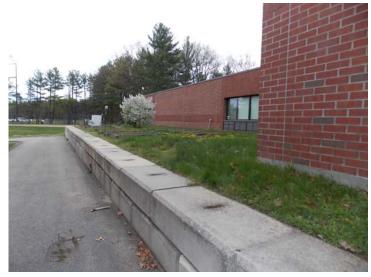
A block retaining wall at the student garden area.

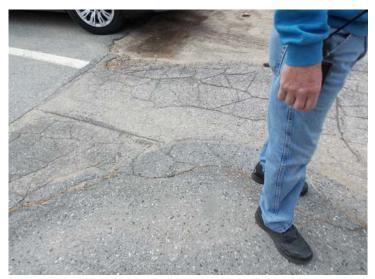
A close-up of cracks in a section of the asphalt paving.

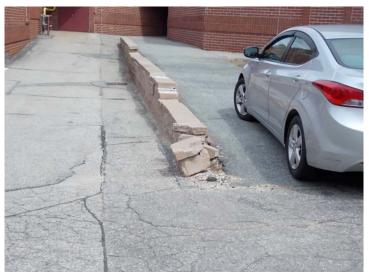
Damage on a section of asphalt paving and this wall.

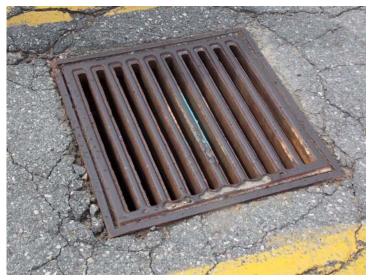
Close-up of damage at this catch basin.

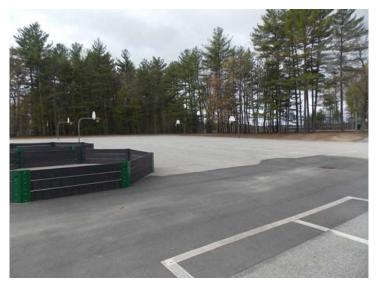
The paved play area.

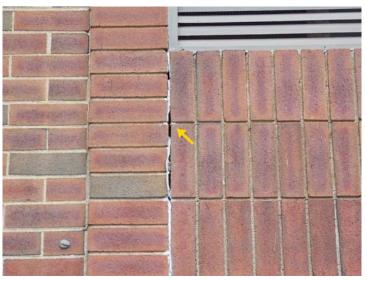
A close-up of missing caulking.

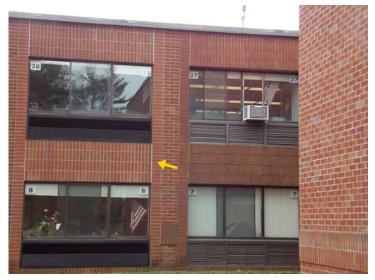
This elevation section shows the newer building wing on the left (arrow) and the older building wing on the right.

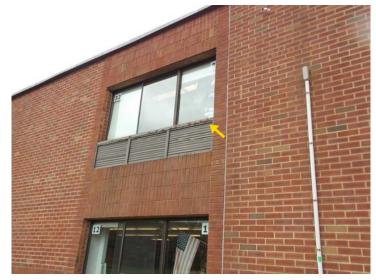
Peeling paint observed on an air intake grill on the older building section.

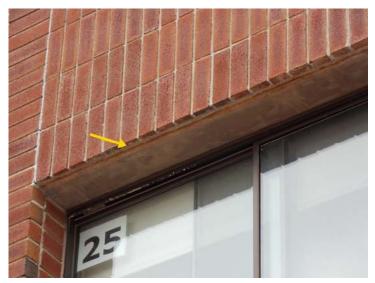
A close-up of a metal lintel that is showing rust along the front edge.

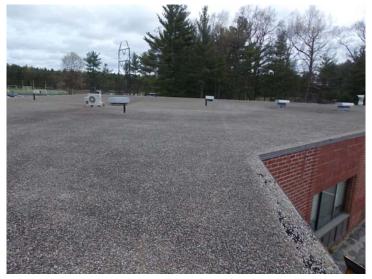
Tar and gravel roof covering on a building section.
