RPF Environmental
TESTING & CONSULTING SERVICES
Hazardous Materials Inspection & Assessment
Asbestos, Mold, Lead Paint, Radon, PCBs
Air Quality Testing and Investigations
Industrial Hygiene, Safety & Training

Re: Biannual Indoor Air Quality Testing
Souhegan High School
RPF File 22.1328

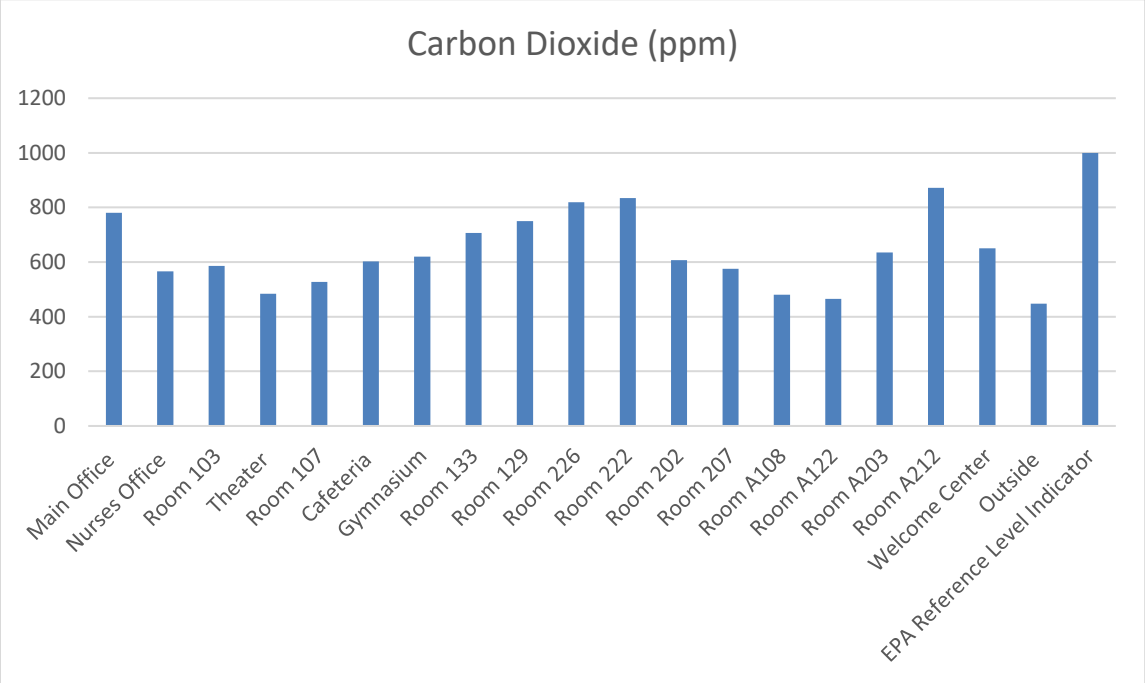
The CO_2 results and testing locations are presented in Appendix A. CO_2 levels at all indoor locations tested were documented in the range of approximately 465 to 872 ppm, which is well below the Occupational Safety and Health Administration Permissible Exposure Limit (OSHA PEL) of 5,000 ppm. These concentration ranges are also below the generally accepted guideline limit of 800 to 1,000 ppm.

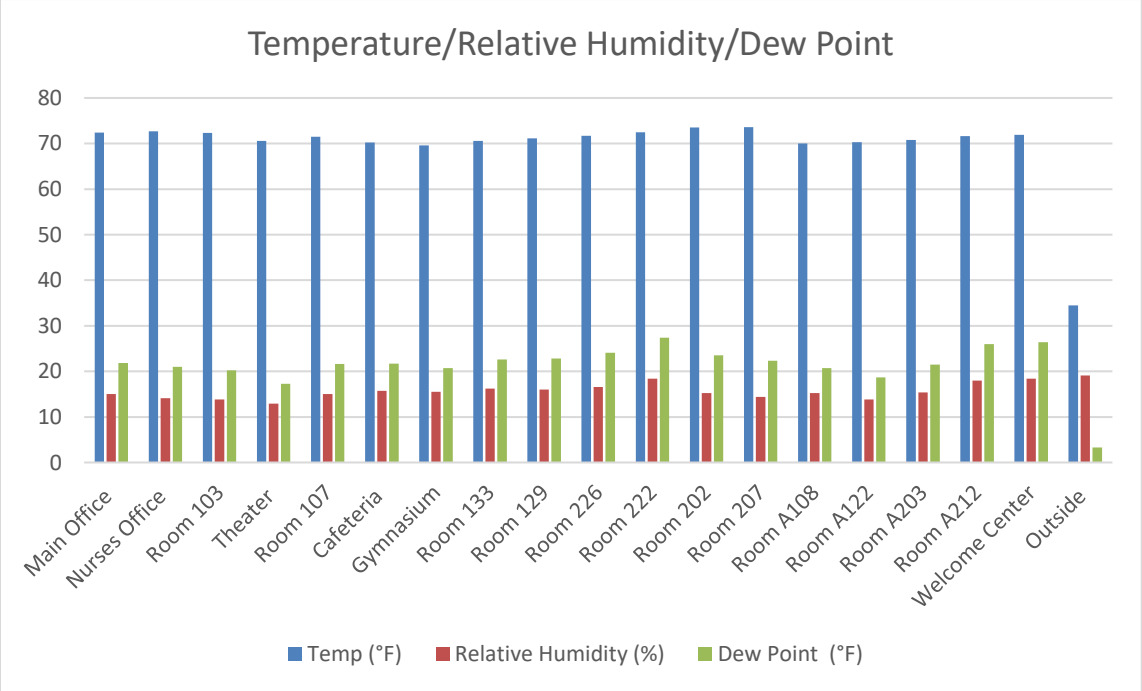
Temperature will affect the occupant's perception of IAQ based on employee comfort levels, effect of drafts or airflow, and humidity levels in a building. In most cases, simple adjustments to thermostats and direction of airflow from registers can improve perceived IAQ. As a reference, the temperatures recommended by ASHRAE for general office space ranges from approximately 68° to 75° Fahrenheit in the winter, and from approximately 75° to 80° Fahrenheit in the summer. Temperature readings at all indoor locations tested were documented in the range of 69.6° to 73.6° Fahrenheit.

The amount of water vapor that can be contained in the air varies by the temperature and pressure of the air. The ratio of water vapor in the air to the maximum amount of water vapor the air can hold at a given temperature is expressed as relative humidity (RH). The recommended RH comfort range is 35% to 55%. In general, for buildings, the presence of excessive moisture can lead to mold growth and other biological contaminants. Low RH, common for buildings in New England during colder months, may contribute to irritated mucous membranes, dry eyes and sinus discomfort while high relative humidity, common in summer, may cause discomfort, as it hinders the body's use of perspiration as a cooling mechanism. RH levels at the indoor locations tested during this survey were below the generally accepted comfort range.

Dew point is related to humidity and is the temperature below which water vapor may start to condense to form water droplets on a surface. If dew forms on interior building materials, the material may become wet, and subsequent fungal growth can occur. For instance, an uninsulated cold-water pipe may form condensation when the temperature of the metal surface is colder than the environmental dew point, and drip onto surfaces causing them to become wet. Dew point measurements on the day of testing ranged from 17.3° to 27.4° Fahrenheit. Based on these results, the interior temperature readings were all above the Dew Point readings. The results and testing locations are presented in Appendix A.

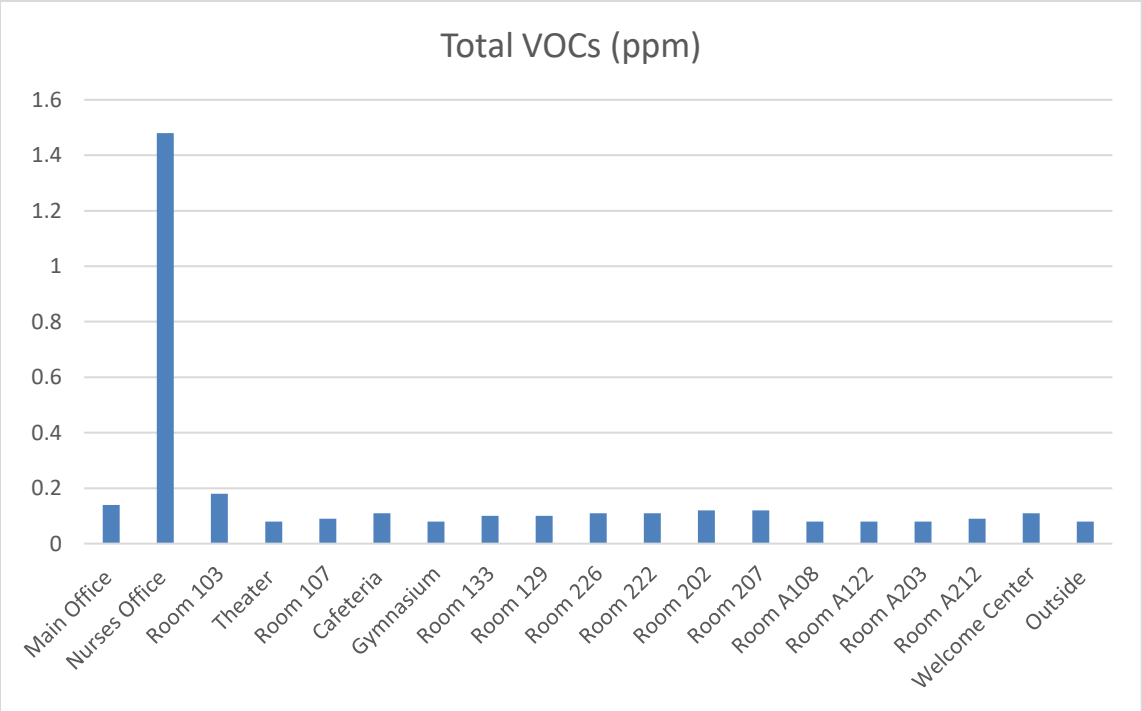
The scope of this survey included screening for total volatile organic compounds (VOCs). During this testing, most of the total VOCs were measured at 0.18 parts per million (ppm) or less for all inside locations, except for one reading collected in the Nurse's office. Most of these readings are within the "normal indoor air" range depicted below and are comparable to the outside air, which had a reading of 0.08 ppm. The nurse's office reading was elevated above the "normal indoor air" range. These results are summarized below and presented in Appendix A.

- Most of the TVOC readings were within the "normal indoor air range" depicted above. However, there was a reading collected in the nurse's office that was elevated above the "normal indoor air" range. While on site, RPF observed a slight chemical odor and various cleaning agents in the Nurse's office, including hand sanitizer, that could have contributed to the elevated TVOC readings. Various compounds, such as cleaning agents, chemicals, paint, air fresheners, hand sanitizer, etc., can produce TVOCs and could have contributed to the elevated TVOC readings present in the above listed areas. As indicated above, investigating the feasibility of increasing the tempered FOA to these areas would help to dilute the concentrations of TVOCs in the air. If concerns continue about the air quality, RPF recommends performing additional VOC testing in order to try to identify the chemical(s).

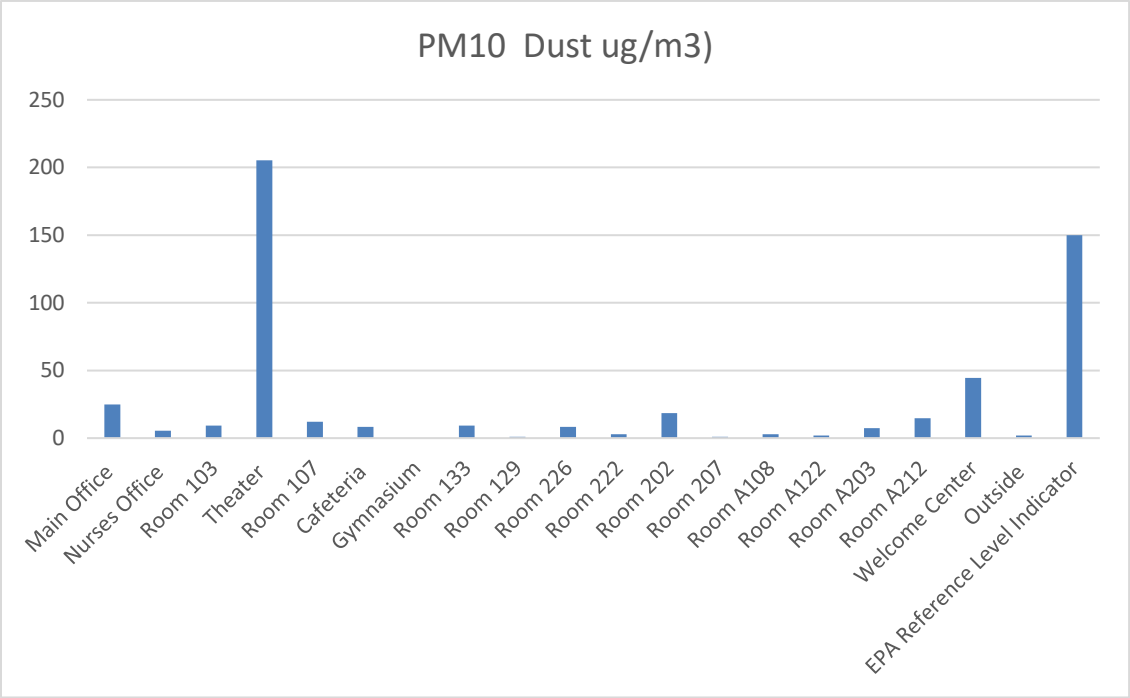
Direct reading determinations for PM_{10} at all indoor locations tested were in the range of approximately <0.01 to 205.25 micrograms per cubic meter of air ($\mu g/m^3$). The results at most of the interior locations tested were elevated above the values found outside, which was approximately 1.85 $\mu g/m^3$. The US EPA does have a National Ambient Air Quality Standard at 150 $\mu g/m^3$ which was exceeded in one reading collected in the theater during the testing. The World Health Organization (WHO) also has set a standard of 50 $\mu g/m^3$ as a 24-hour average and 25 $\mu g/m^3$ as an annual average exposure. These results and testing locations are presented in Appendix A.

These results indicate that the HVAC filters are not reducing the overall particle loading inside the building when compared to the outside air. For a building that implements the use of an HVAC system, it is typical to see a 25% to 35% reduction in total particulates inside a building compared to the outside concentration of particulates while the HVAC units are operational. The feasibility of upgrading the HVAC systems' filter efficiency rating could be investigated if complaints were to increase at this building. The American Society of Heating, Refrigeration, and Air Conditioning Engineers (ASHRAE) has recommended filter minimum efficiency reporting value (MERV) of not less than six (6) for filters in HVAC systems supplying air to occupied office space (ASHRAE Standard 62.1-2004-5.9). A recent ASHRAE guidance regarding building operations during the Covid-19 pandemic has also recommended increasing the filter efficiency to the highest rating compatible with the HVAC system, up to MERV-13, and sealing the edges of the filter to limit air bypass. Follow the manufacturer's recommendations for a filter change out schedule.

- Most of the readings collected within the building were elevated above the outside control but well below the NAAQS of 150 ug/m^3, except for a reading collected in the theater which was above the standard. It should be noted that the theater was under construction at the time of the survey as they were building a stage. This construction activity could have contributed to the elevated concentration of PM10 in the theater. RPF recommends installing dust controls during active constructions to decrease the amount of PM10 in the air. RPF also recommends the feasibility of increasing/adding FOA to these areas. As indicated above, investigating the feasibility of upgrading the filters to a better MERV rating (such as MERV-13) could help make the system more efficient in removing particles.

- Heating systems should be inspected on an annual basis or more frequently as required by the manufacturer. RPF recommends implementing and maintaining a preventative maintenance and inspection program for the HVAC system including air filter change-out schedule on a quarterly basis and inspecting for the proper seating of air filters within the filter housing of each air handling unit in order to help eliminate potential air bypass of air filters.
