Capital Needs Assessment

Wilkins Elementary School

June 1, 2017

Preliminary Report

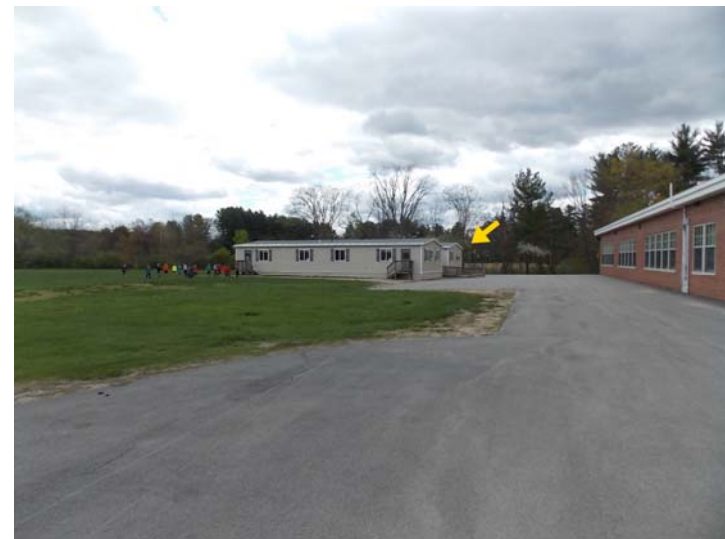
There is also a pair of vinyl clad portable buildings that add an additional four classrooms to this campus.

13. The cost to replace the caulking, in which there were sections found to be dried, cracked, and in some isolated areas voids were also noted, is shown in Years 1 and 16. The wood trim (fascia boards and soffits) are to be repaired and repainted in Years 1, 8, and 15. The shed that is attached to the main building clad with plywood, which is starting to deteriorate. The plan includes the cost to replace the plywood with a cementitious fiberboard product in Year 1. The brickwork appears to be in good condition and future repointing is shown in Year 16. The vinyl siding is to be power washed every six years starting in Year 4.

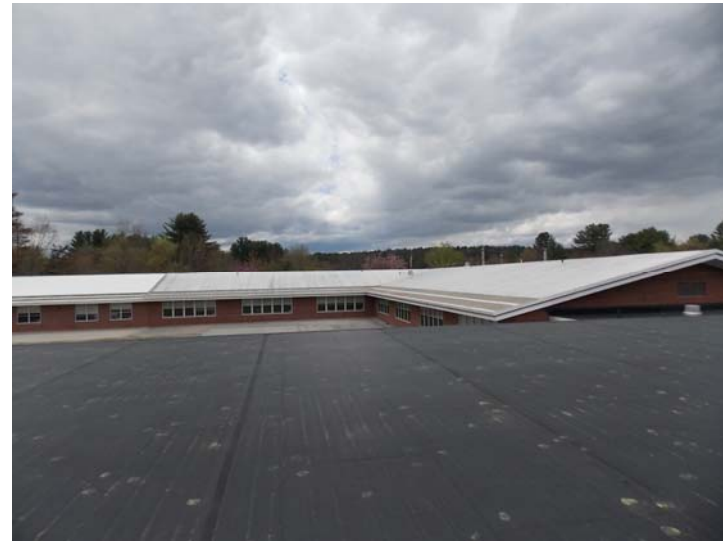
16. Overall, the roof coverings appear to be in good condition. The PVC membrane is to be replaced over a two-year period starting in Year 12. The rubber membrane is to be replaced in Year 14 preferably with a PVC membrane, which will provide a cooling benefit to the building during the summer months. The architectural shingles are to be replaced in Year 15.

On the main building, the flat roof is covered with a rubber membrane and the pitched roof is covered with a PVC membrane.

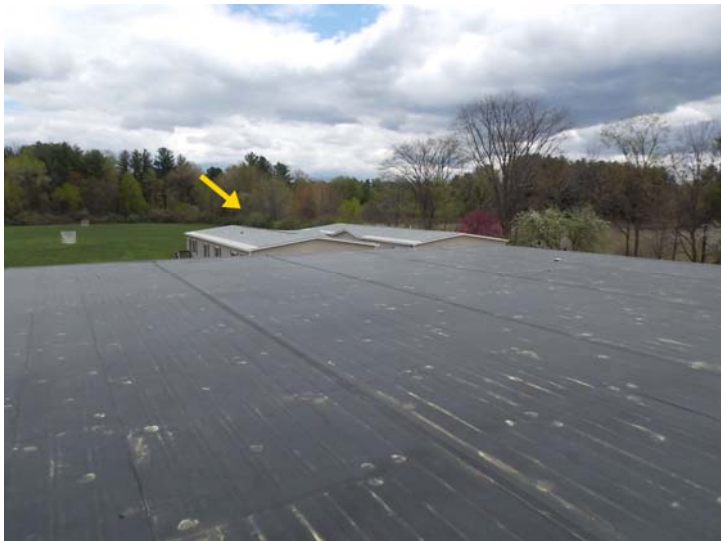
The portable building roofs are covered with architectural shingles.

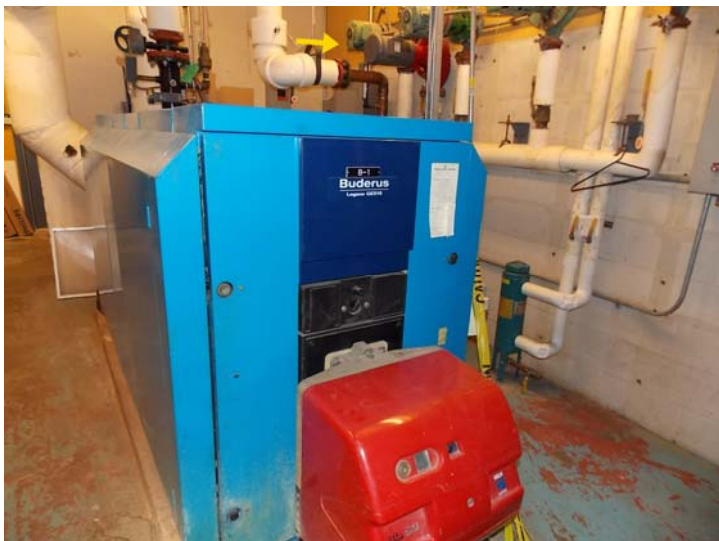
One of the 2 oil-fired hydronic heat boilers.

5. **Costs related to the development's boilers and boiler room systems total \$115,063 or \$2.08 per square foot in inflated dollars.**
6. The cost to upgrade the EMS is shown in Years 7 and 14. The boilers are to be serviced in Year 10. The DHW tanks are to be replaced every 12 years starting in Year 4.

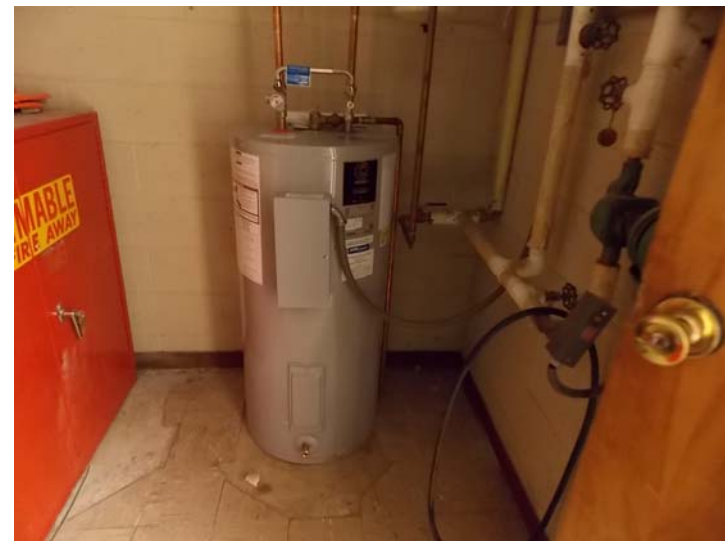
One of the electric-heated DHW tanks.

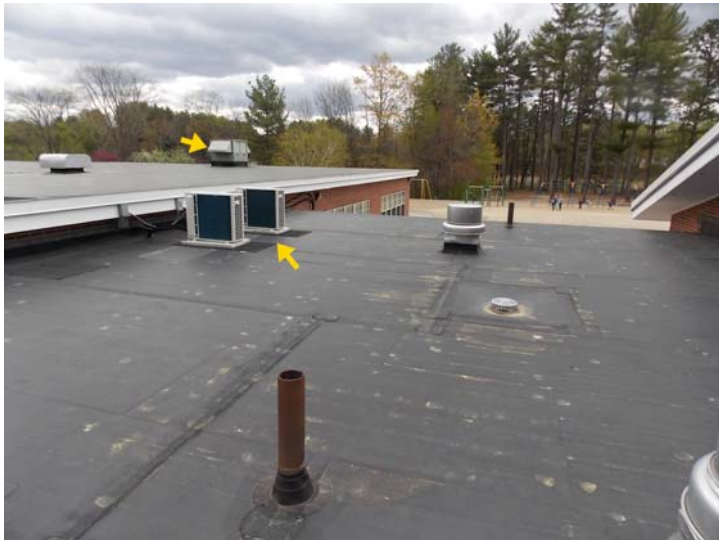
Rooftop equipment includes air-cooled condensers (lower arrow) that are part of split DX air conditioning systems, heat recovering make-up air units (upper arrow), and rooftop exhaust fans.

10. The ceiling mounted air handler that serves the Multipurpose Room is to be upgraded (heating coil, controls, blower motor, etc.) in Year 5. The split direct expansion (DX) air conditioners are to be replaced in Year 10. The plan also anticipates replacing damaged finned tube radiation starting in Year 10. The exhaust fans are to be upgraded in Year 12.

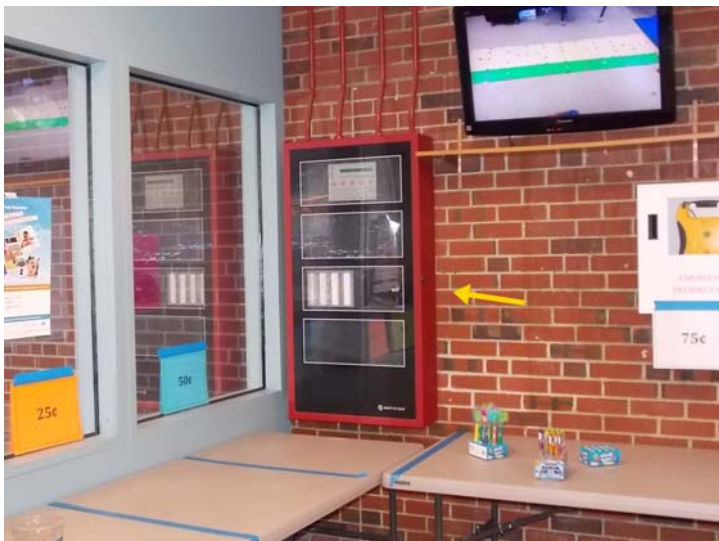
This is the fire alarm control panel.

circuit breaker panel is a safety concern in that it has a history not reliably reacting to an electric overload condition. An allowance to upgrade the video monitoring system, public address system, and the central clock is Years 2, 9, and 16. The battery powered emergency lights are to be replaced in Years 7 and 17. The fire alarm system is to be upgraded in the second half of the plan in Year 12.

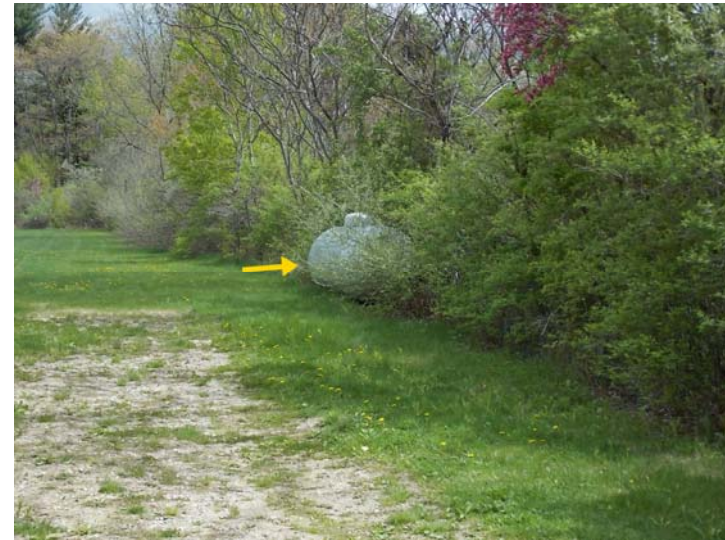
A propane storage tank that is no longer in use.
