Capital Needs Assessment

Clark School

May 31, 2017

Preliminary Report

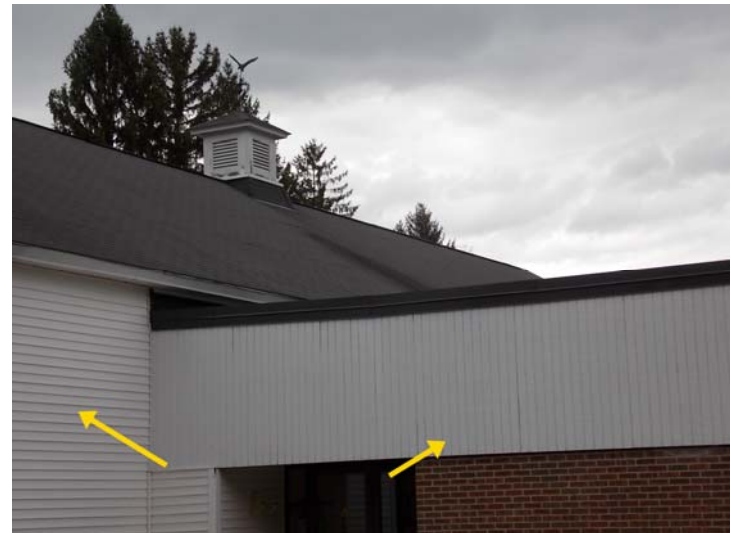
The building is clad with vinyl (left arrow), T1-11 (right arrow) and brick.

13. The vinyl siding, especially on the new building wing has a number of areas damaged by impact. Also, the T1-11 siding is showing signs of initial deterioration. The plan includes the costs to replace these existing building siding materials with a cementitious fiberboard product in Year 1, which will provided a more resilient and effective exterior wall finish than either the vinyl or T1-11. The brickwork appears to be in good condition and future repointing is shown in Year 16.
14. An allowance for anticipated failed window glazing replacement is shown starting in Year 12. Replacement of the service doors is shown in Year 18 and the secondary doors (classrooms and hallway) in Year 20.

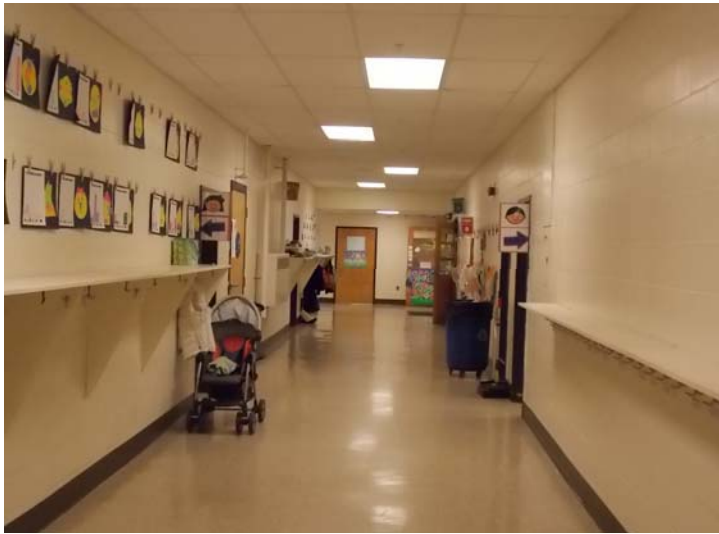
The main hallway has ceiling tiles, painted walls and VCT flooring.

17. Wall repainting and ceiling tile is shown every ten years starting in Year 7. Replacement of the vinyl composite tile (VCT) flooring is shown in Year 17. Also, allowances to replace classroom furnishings and equipment start in Year 5. Upgrade of the hallway shelving and coat hangers is shown in Years 7 and 17.

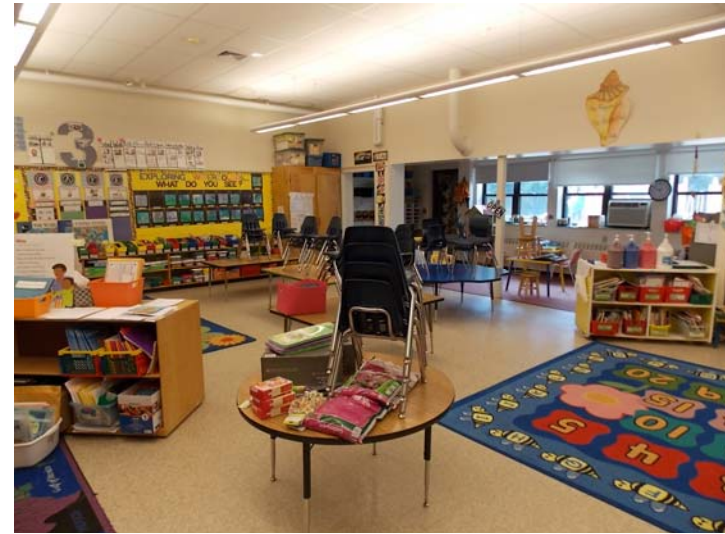
Classrooms also have ceiling tiles, painted walls and VCT flooring. Energy efficient fluorescent lighting (T8 lamps with electronic ballasts) are used throughout the facility.

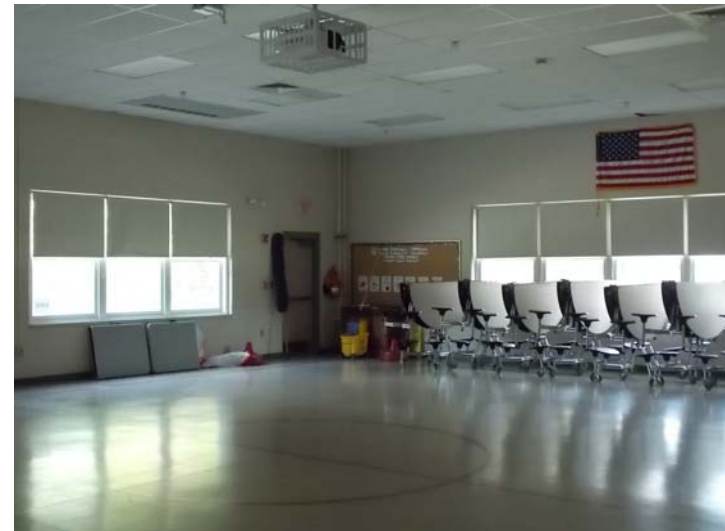
This is the recently added multipurpose room.

18. Replacement of ceiling tiles and repainting walls in the new building wing (Multipurpose Room and the Music/Arts Room are shown in Years 3 and 13.
- 19. Costs related to the school's support areas total \$86,798 or \$3.21 per square foot in inflated dollars.**

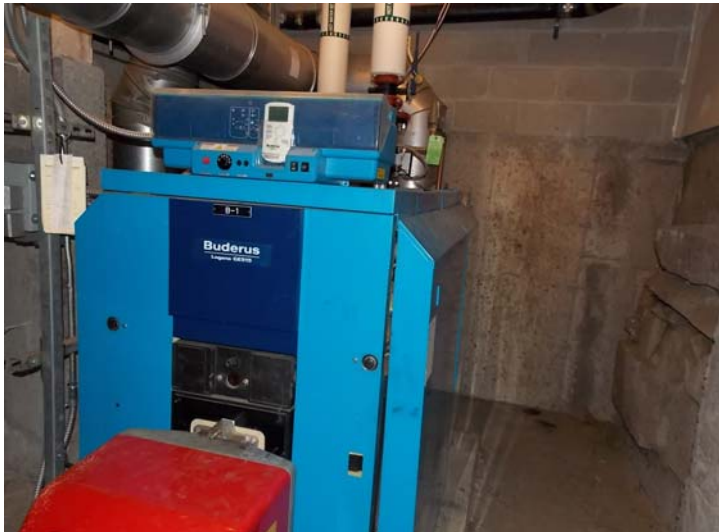
This is the new oil-fired boiler.

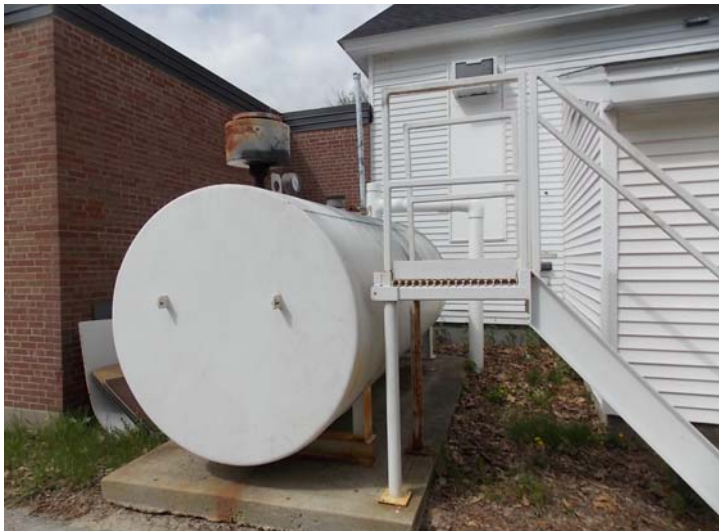
This is the above-ground double wall fuel oil storage tank.

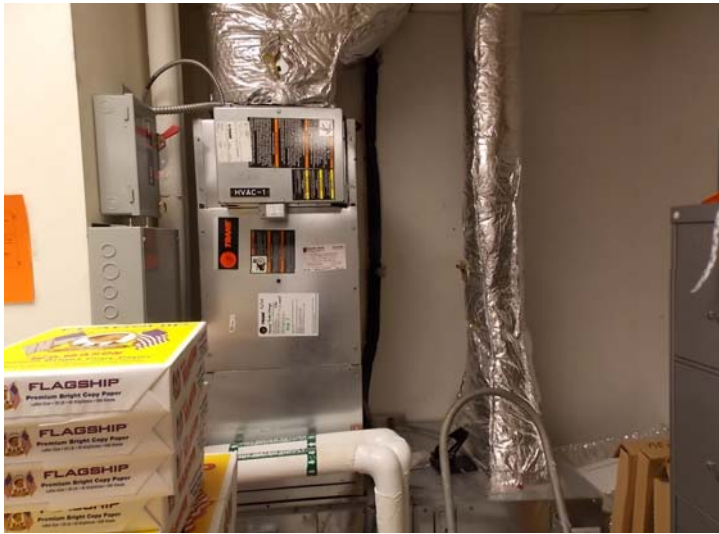
One of the air handlers.

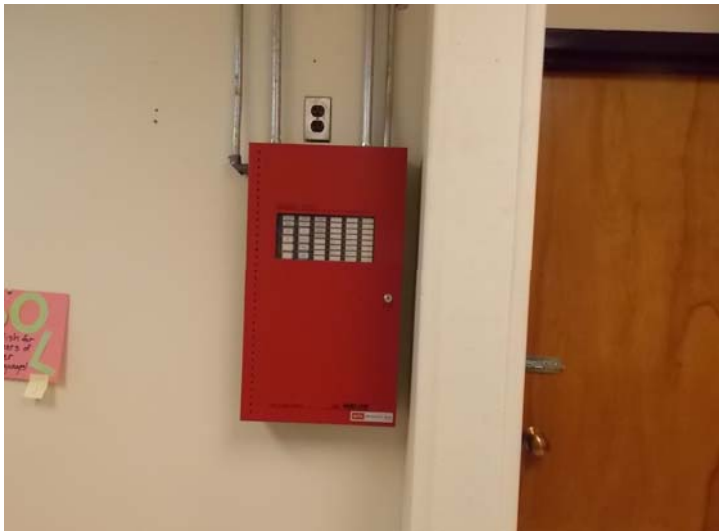
A view of the fire alarm control panel (FACP).

10. An allowance to upgrade the video monitoring system, public address system, and the central clock is Years 1, 8, and 15. The battery powered emergency lights are to be replaced every ten years starting in Year 7. The fire alarm system is to be upgraded in the second half of the plan in Year 13.
11. The Garaventa chair lift station, added during the latest renovation provides access to the library, which is located on the second floor. No capital improvement to the chair lift station is anticipated during this 20-year plan.

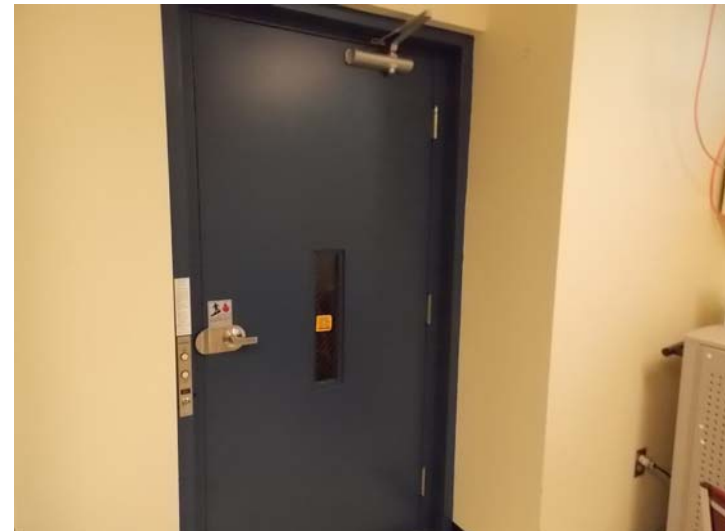
This Garaventa Lift (chair lift) is located in the original building wing and provides access to the three levels (basement, 1st and 2nd floors).
