November 7, 2019

Re: Indoor Air Quality Testing SAU Office, Amherst, NH RPF File No. 177888

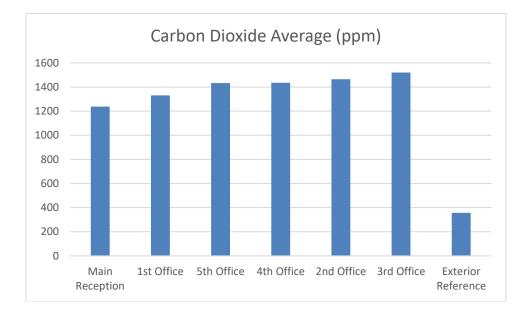
The CO₂ results and testing locations are presented in Tables 1and 2 of Appendix A. CO₂ levels on September 16, 2019 at all indoor locations tested were documented in the range of approximately 1,238 to1,520 ppm, which is well below the Occupational Safety and Health Administration Permissible Exposure Limit (OSHA PEL) of 5,000 ppm.

The American Society of Heating, Refrigerating and Air Conditioning Engineers (ASHRAE) recommends a guideline in their Standard 62-2001 for Ventilation for Acceptable Indoor Air Quality for a maximum of 700 ppm CO_2 above outside air concentrations as a value under which employee complaints are minimized. On September 16, 2019, the outdoor ambient concentration of CO_2 was recorded at 357 ppm with a corresponding value of 1,057 ppm. On September 17, 2019, the outdoor ambient concentration of CO_2 was recorded 353 with a corresponding value of 1,053. The ASHRAE standard also calls for a minimum of 20 cubic feet of outside air (FOA) per minute per occupant be introduced into office spaces in order to maintain dilution of contaminants and perceived indoor air quality. The feasibility of bringing in more FOA should be investigated.

According to the USEPA, pollutant or contaminant source control is usually the most effective way to improve indoor air quality. If source control efforts are not sufficient, increasing the amount of outdoor air coming indoors may prove to be helpful.

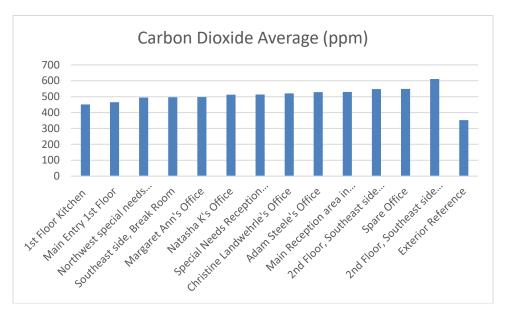
CO₂ levels on September 17, 2019 at all indoor locations tested were documented in the range of approximately 461 to 611ppm. These concentrations are below the generally accepted guideline of 800 to 1,000 ppm.

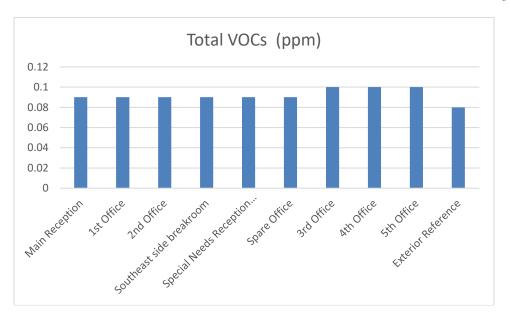
The scope of this survey includes a total VOCs screening, and not specific chemical testing for the makeup of the overall VOCs detected. During this testing, total VOCs were measured at 0.10 ppm or less for all interior locations on the 16th. These values were elevated above the exterior value of 0.08 ppm.

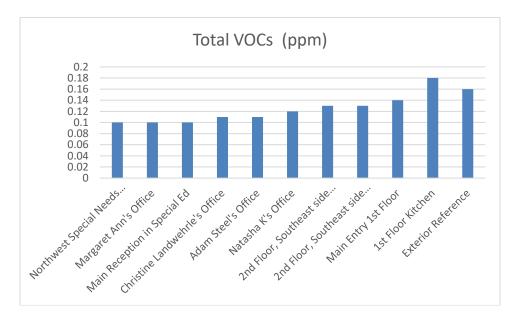
VOC readings taken at all interior locations on the 17th were measured at 0.18 ppm or less with subsequent average reading of 0.16 ppm. These results are summarized below and presented in Tables 1 and 2 of Appendix A.

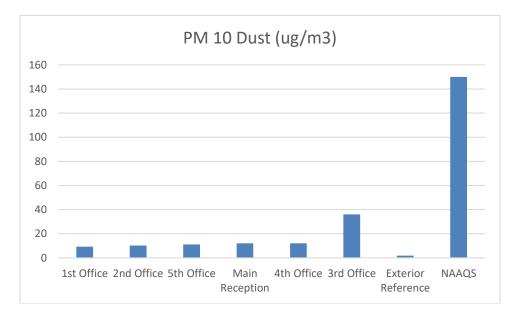
Direct reading determinations for PM_{10} , inhalable particles with diameters that are generally 10 micrometers and smaller, at all indoor locations on the 16th were documented in the range of approximately 9.25 to 36.06 micrograms per cubic meter of air (μ g/m³). The results at all of the interior locations were elevated above the exterior value, which was approximately 1.85 μ g/m³.

The World Health Organization (WHO) has set a standard of $50 \,\mu g/m^3$ as a 24-hour average and $25 \,\mu g/m^3$ as an annual average exposure. These results and testing locations are presented in Tables 1 and 2 of the Appendix A. For a building that implements the use of an HVAC system, it is typical to see a 25% to 35% reduction in total particulates inside a building compared to the outside concentration of particulates while the HVAC units are operational.

Other steps to reduce indoor PM_{10} concentrations include; proper ventilation, away from HVAC intakes, of combustion appliances to the outdoors, proper exhaust vents in cooking areas, proper use of wood stoves, and professional maintenance of heating systems.
